**FEDERAL ON-SCENE COORDINATOR'S
REPORT
for
ALIQUIPPA TIN MILL SITE
ALIQUIPPA, BEAVER COUNTY, PENNSYLVANIA
May 27, 2017 to June 30, 2020**

UNITED STATES
ENVIRONMENTAL PROTECTION AGENCY
REGION III
WHEELING, WEST VIRGINIA

**Federal On-Scene Coordinator's Report
Aliquippa Tin Mill Site**

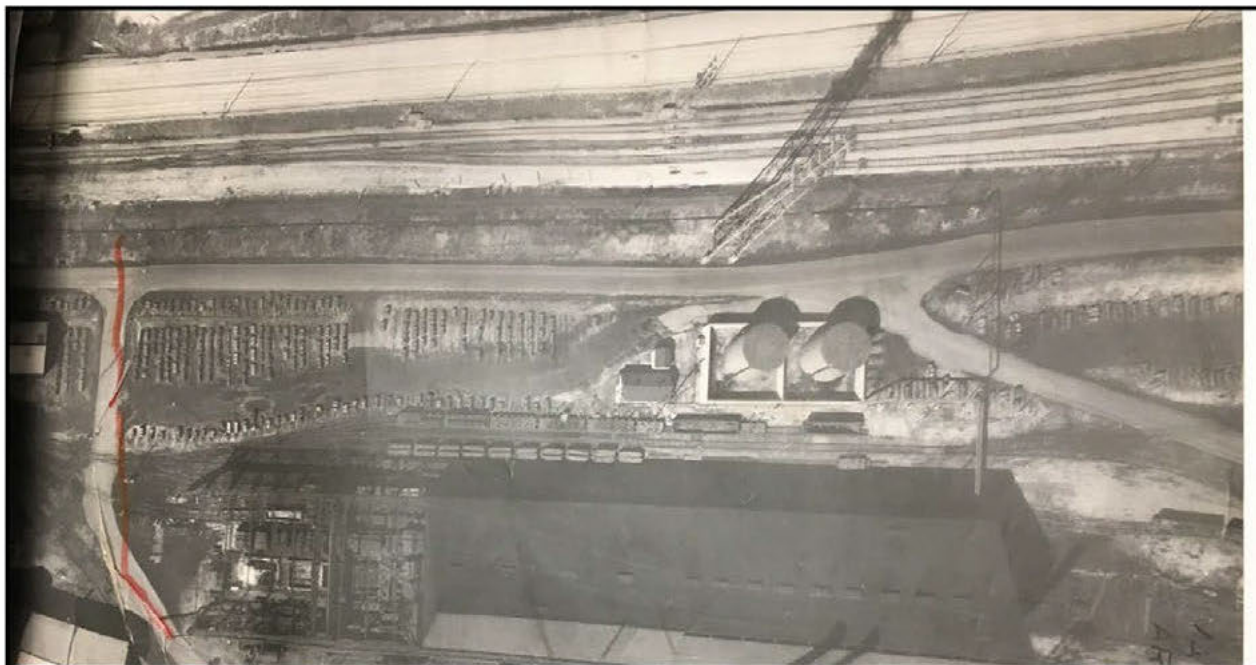
Photolog 1 - Aerial Photograph of the Aliquippa Tin Mill dated 1975. Shows location of aboveground storage tanks at the corner of Woodlawn Rd and Steel St. (Photo taken by EPA from a photo at C.J. Betters office)

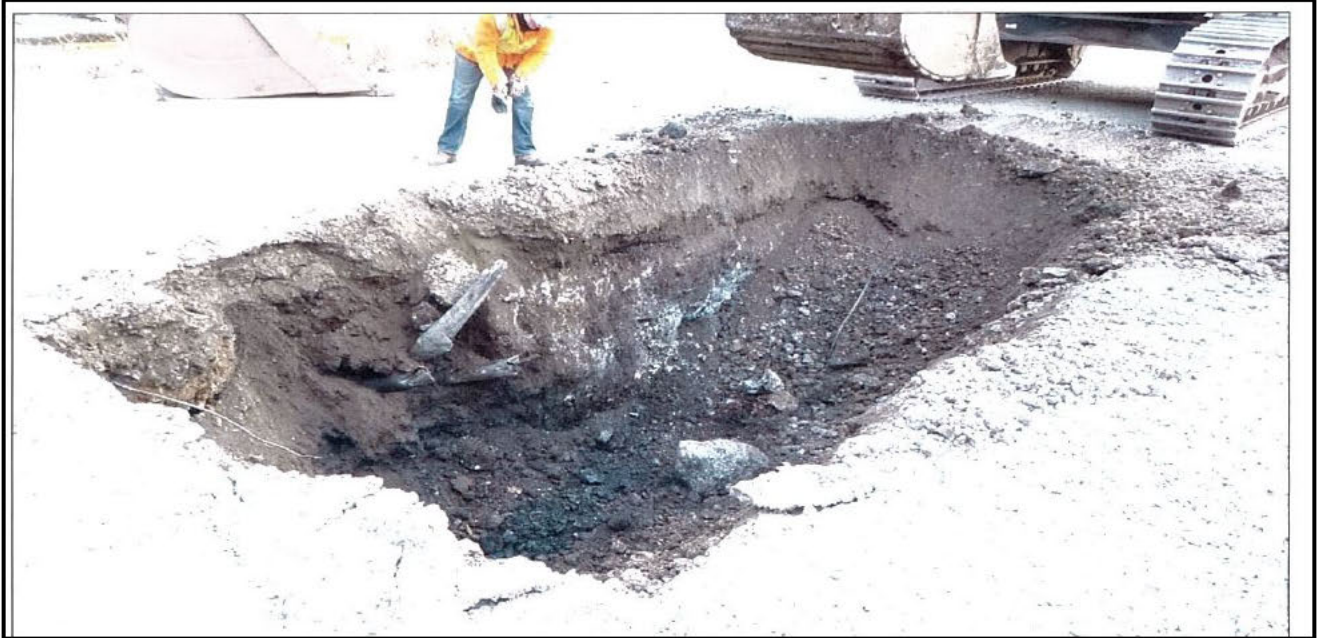
Photolog 7 - Test Pit Excavation on December 8, 2017. Location of sheared piping of 4-in lines (photo provided by C.J. Betters - Photo 4)

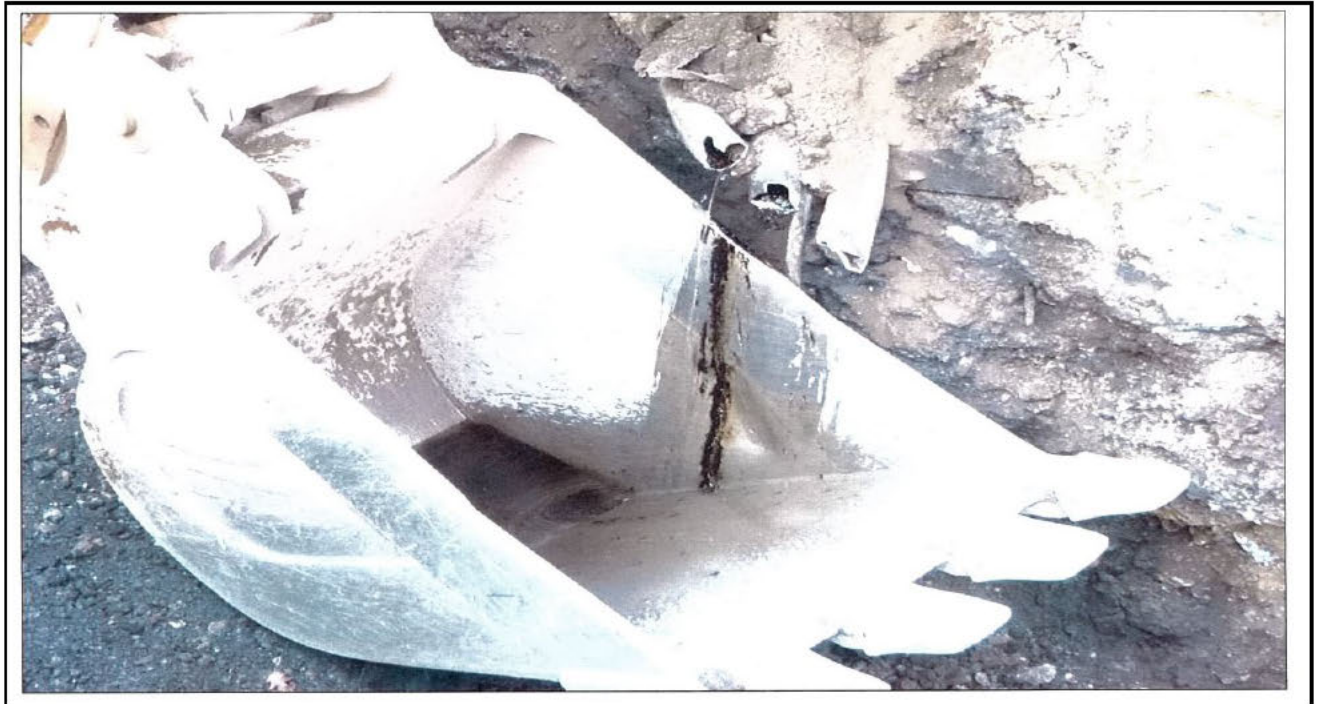
Photolog 8 - Test Pit Excavation on December 8, 2017. Sheared 4-in piping with oil and water inside the piping. (photo provided by C.J. Betters - Photo 6)

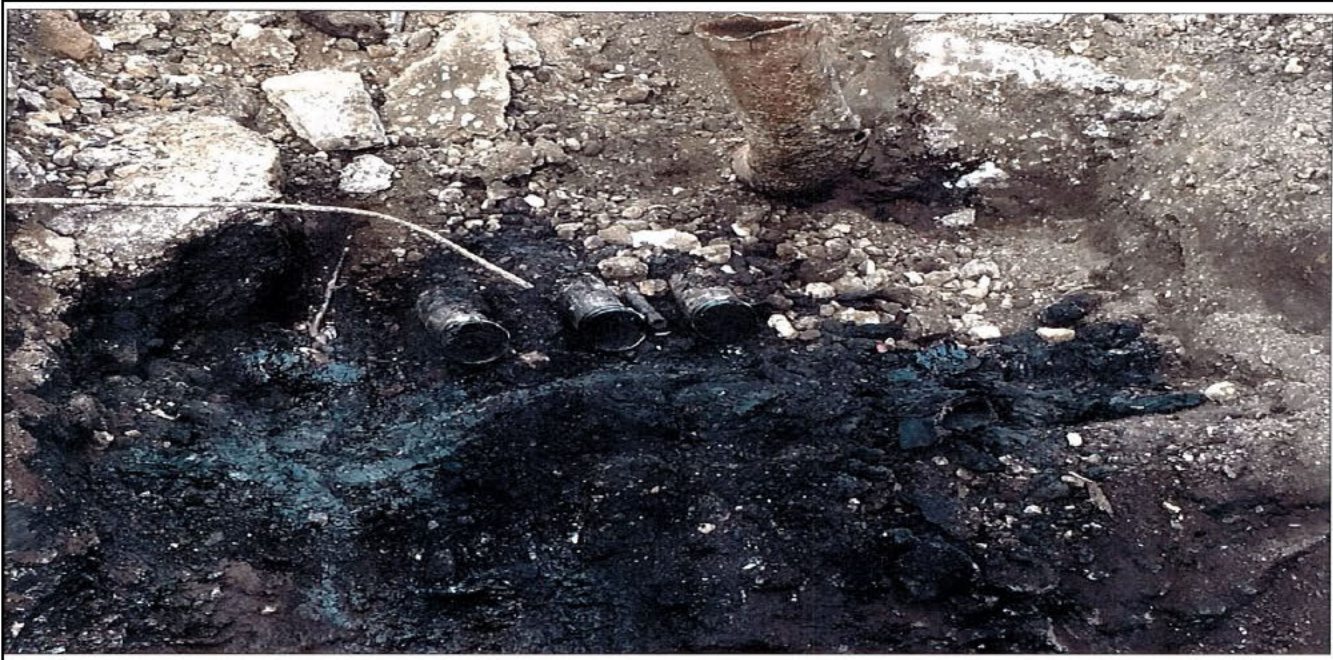
Photolog 9 - Test Pit Excavation on December 8, 2017. Piping cut back to place temporary plugs. Evidence of contaminated soil underneath the piping (photo provided by C.J. Betters - Photo 10)

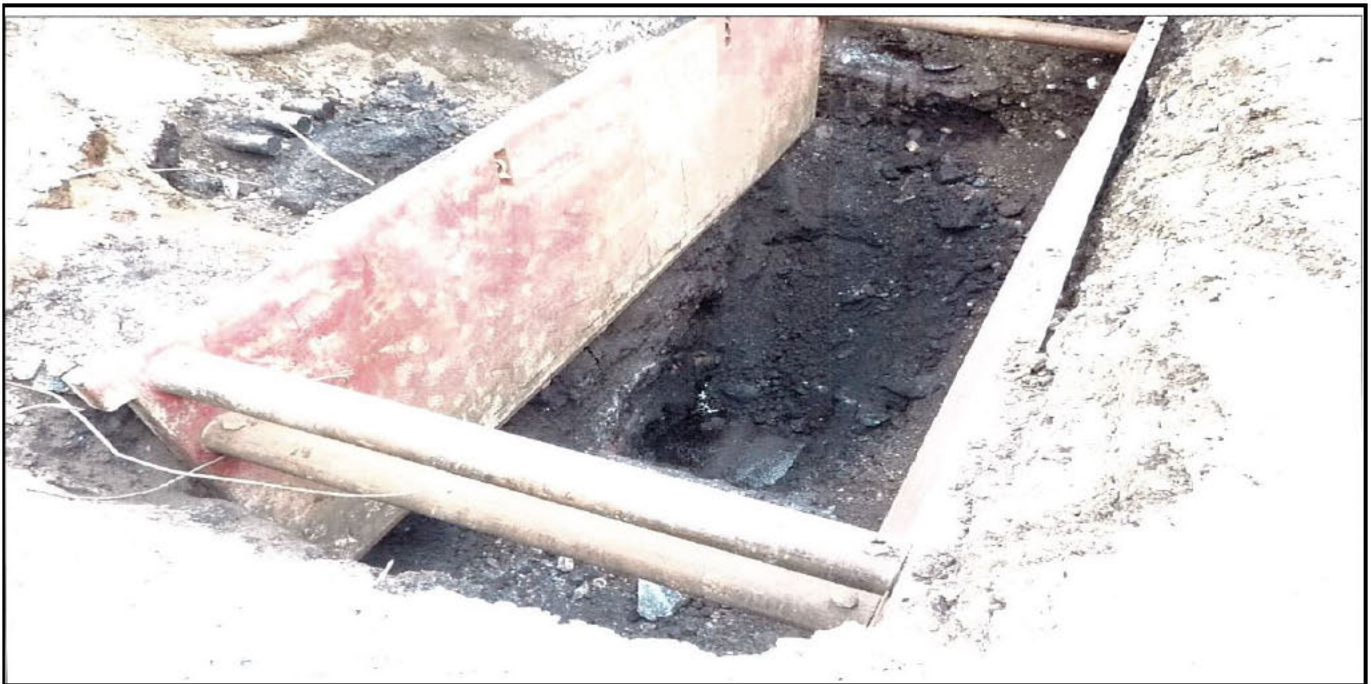
Photolog 10 - Test Pit Excavation on December 8, 2017. Excavation down to water table. Contaminated soils and oil on the water. (photo provided by C.J. Betters - Photo 12)

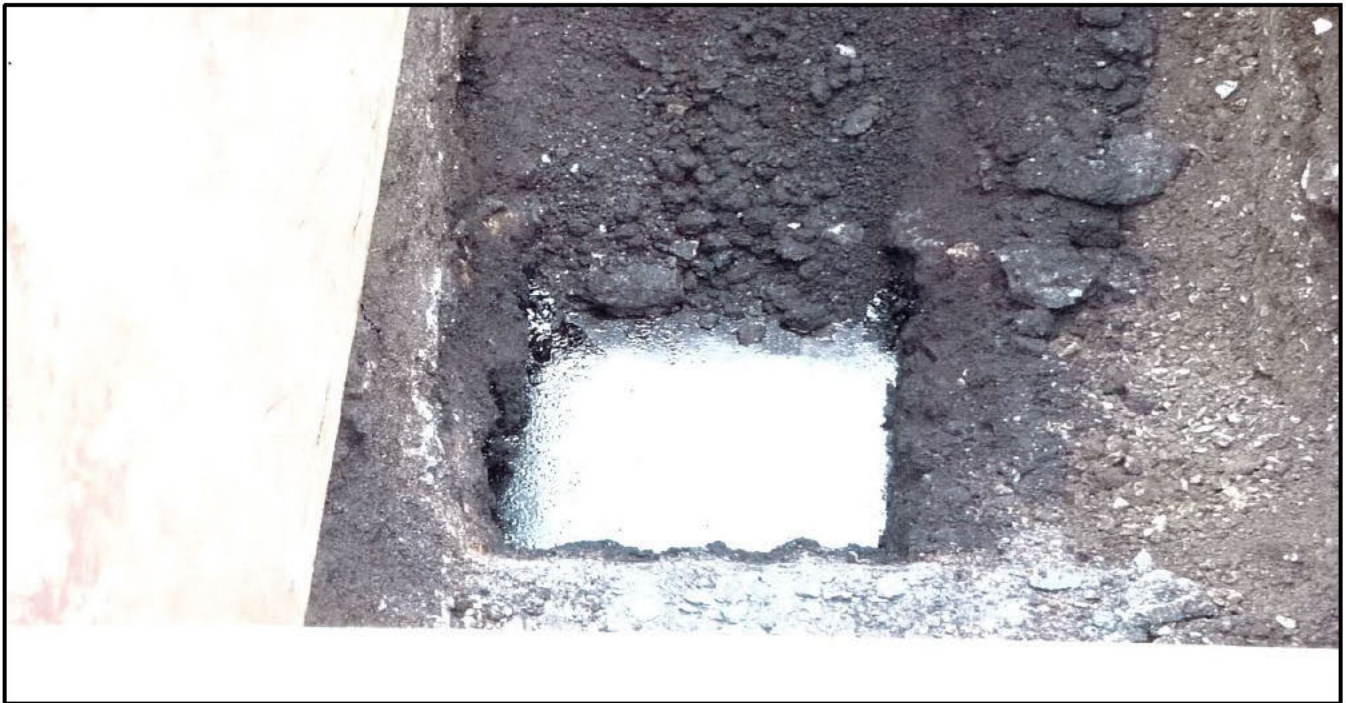
Photolog 21 - Test Pit Excavation on December 8, 2017. Close up picture of excavation with oil at the water level. (photo provided by C.J. Betters - Photo 13)

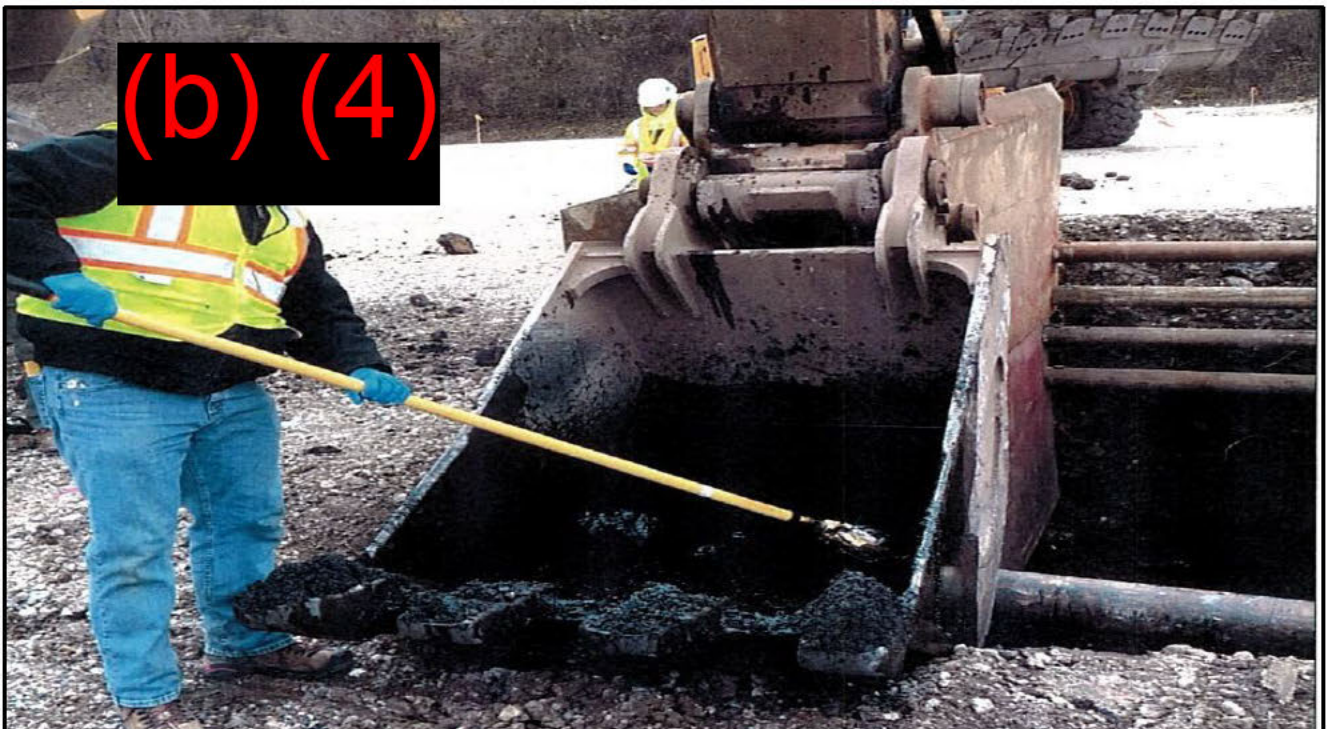
Photolog 32 - Test Pit Excavation on December 8, 2017. Contaminated soil inside bucket removed during excavation. (photo provided by C.J. Betters - Photo 14)

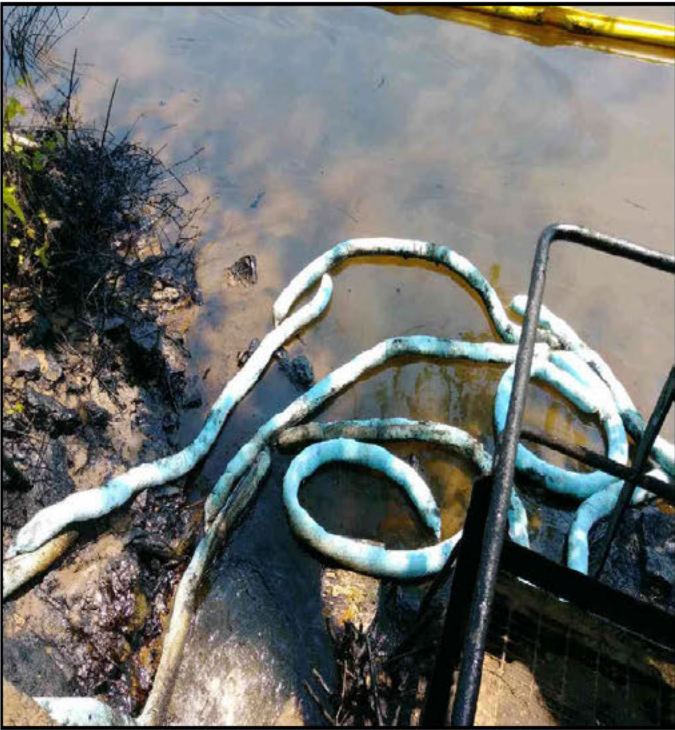
Photolog 25: Conditions after cleanup activities and boom changeout on May 29, 2018. (ERRS photo: 4845.jpg)

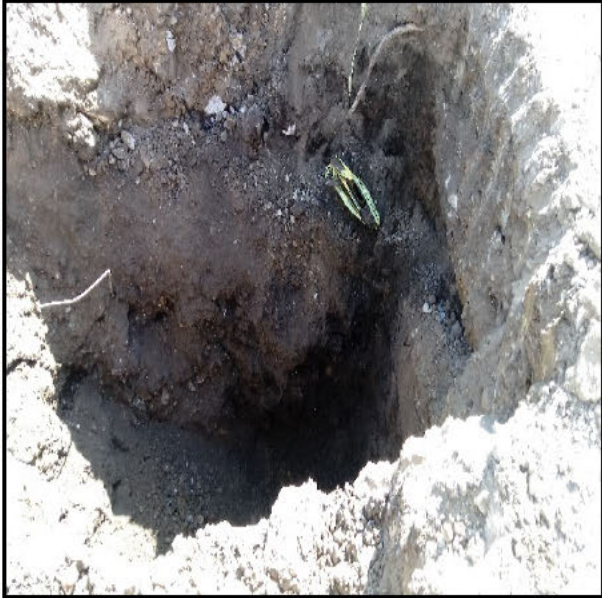
Photolog 35: Test pit conducted on the northern side of the work area near Steele Street on 10/10/18. Oil seeps observed. (START photo 1010181312.jpg)

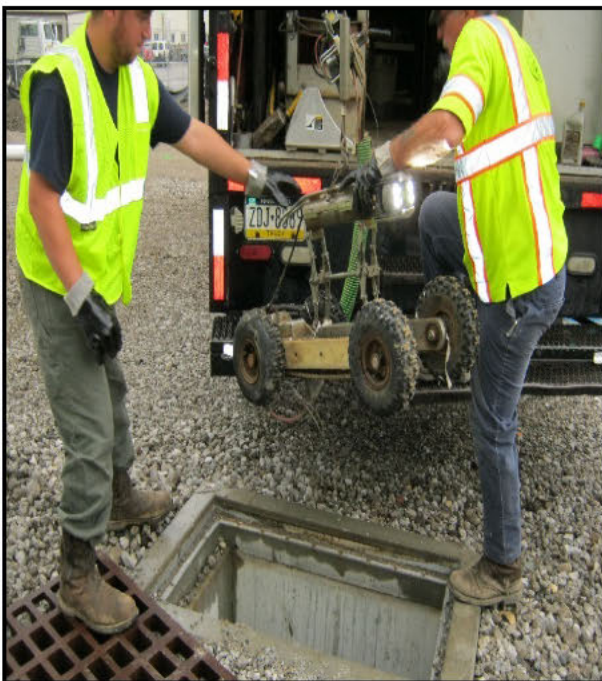
Photolog 37: Subcontractor preparing to conduct camera survey of piping. Camera being lowered into inlet #8. 10/11/18 (START photo IMG_0821.jpg)

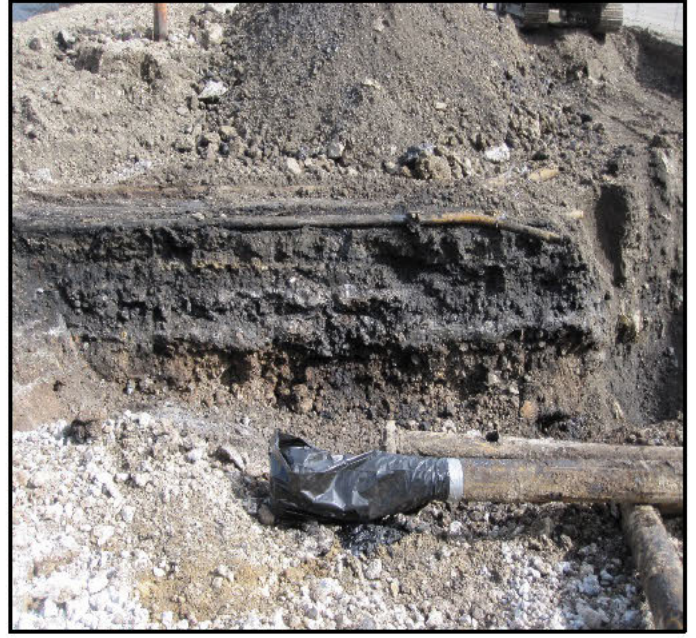
Photolog 40: - Side profile of the nestled piping looking to the east. Oil contamination below piping. Not continuous to 19 feet. 10/15/18. (START photo IMG_1067.jpg)

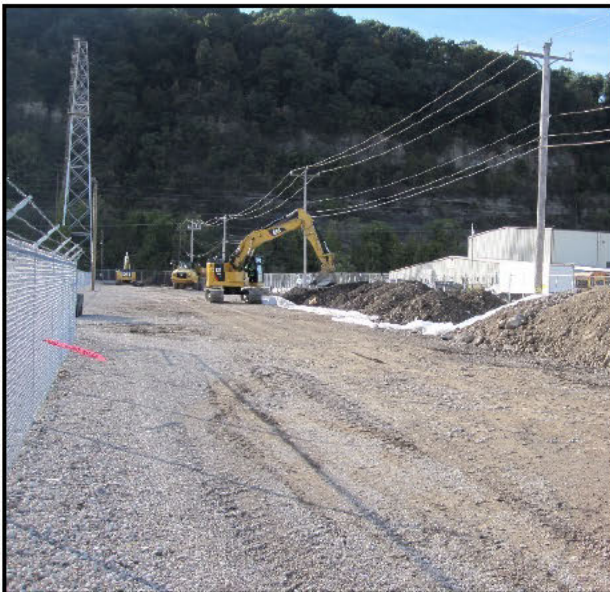
Photolog 45: Stockpiling oil-contaminated soils. Limited work area due to power lines. 10/16/18. (START photo IMG_1077.jpg)

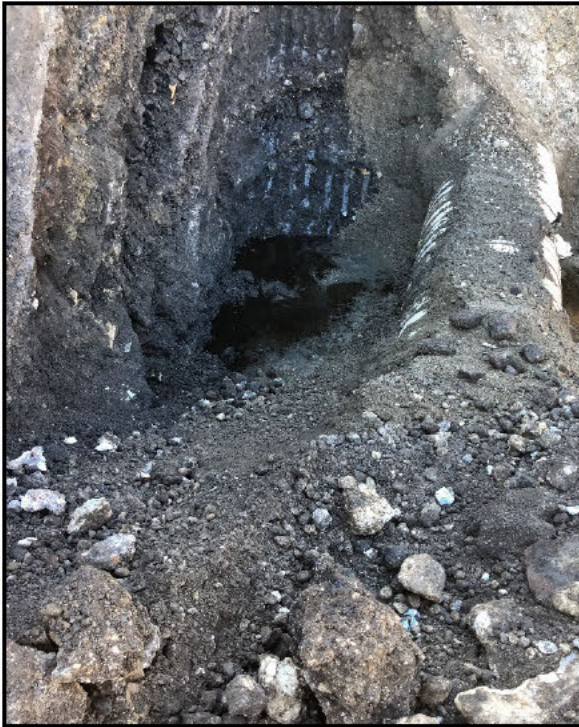
Photolog 47: Excavation on the south side of storm water piping. Water table at 19-20 feet. Oil seeps impacting water. 10/18/18. (START photo IMG_1546.jpg)

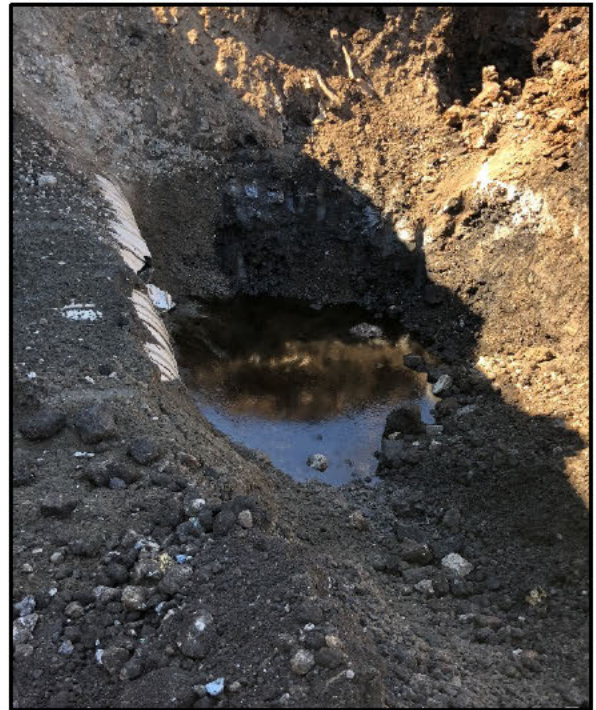
Photolog 48: - Excavation on the north side of storm water piping. Water table at 19-20 feet. Oil seeps impacting water. 10/18/18. (START photo IMG_1551.jpg)

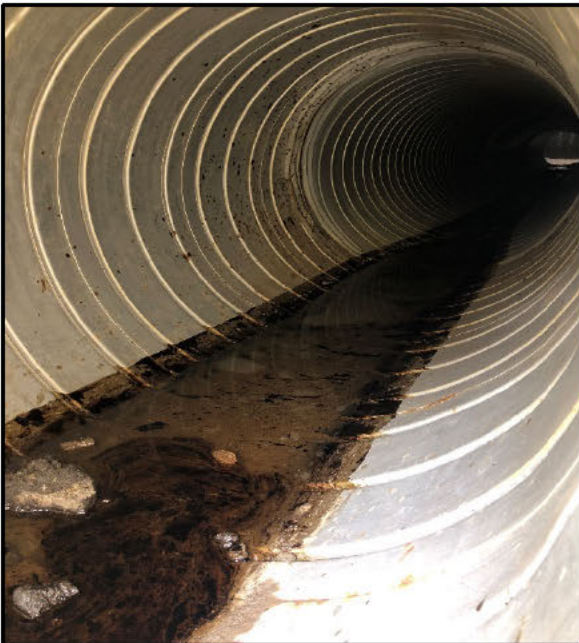
Photolog 49: - Water mixed with oil inside the storm water piping. 10/19/18. (START photo IMG_1561.jpg)

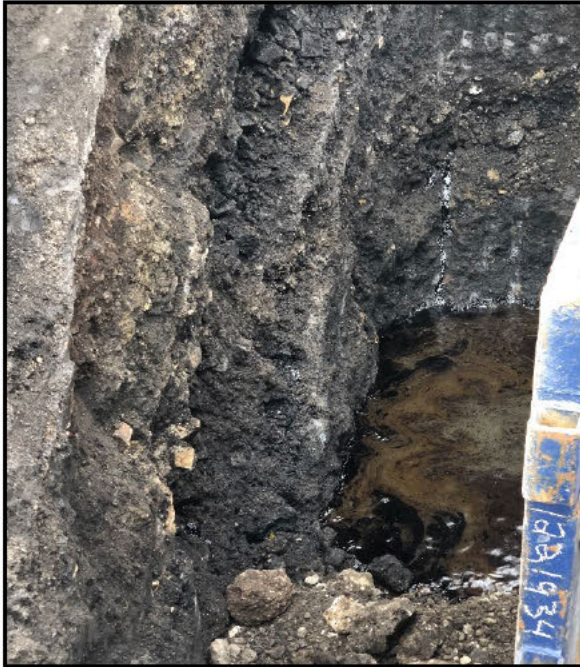
Photolog 51: - Oil from seeps on the sidewall impacting the groundwater. South side of the stormwater piping. 10/19/18. (START photo IMG_1570.jpg)

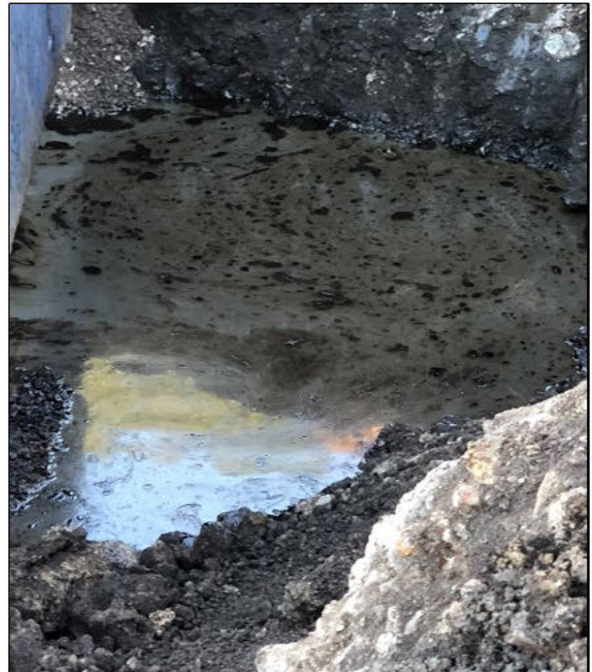
Photolog 52: - Pocket of oil uncovered while excavating on the north side of the storm water piping. 10/22/18 (START photo IMG_1582.jpg)

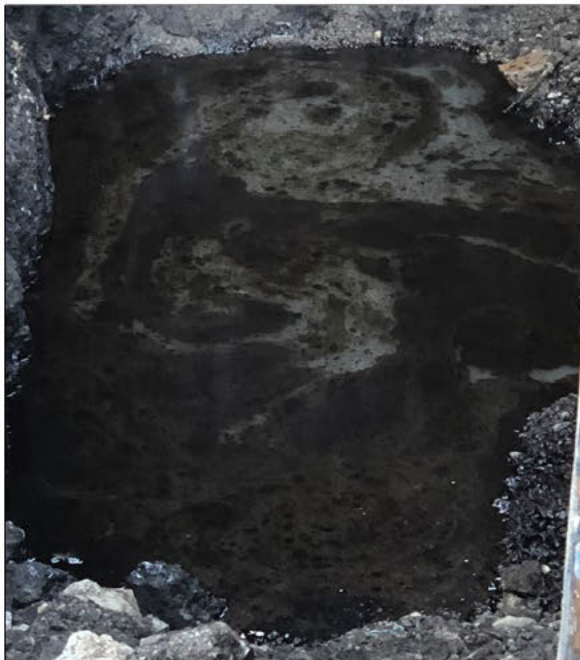
Photolog 53: Amount of oil on the water table after 1 minute. 10/22/18 (START photo IMG_1583.jpg)

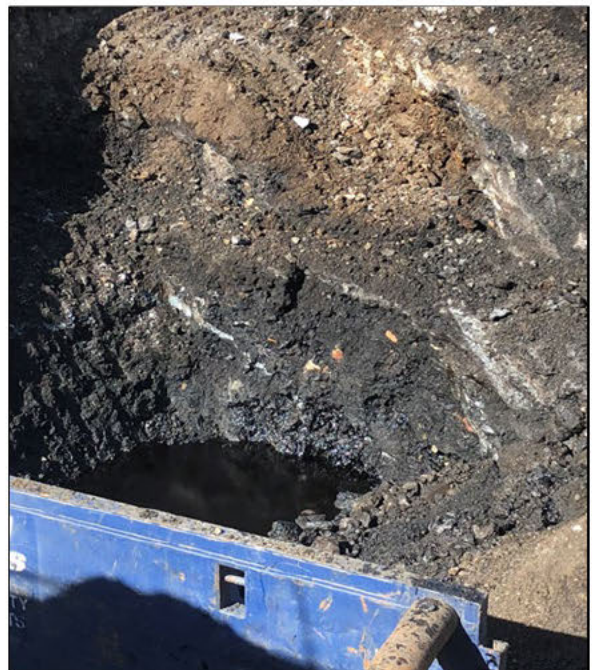
Photolog 54: - Oil covers the surface of the excavated area after 5 hours. 10/22/18. (START photo IMG_1596.jpg)

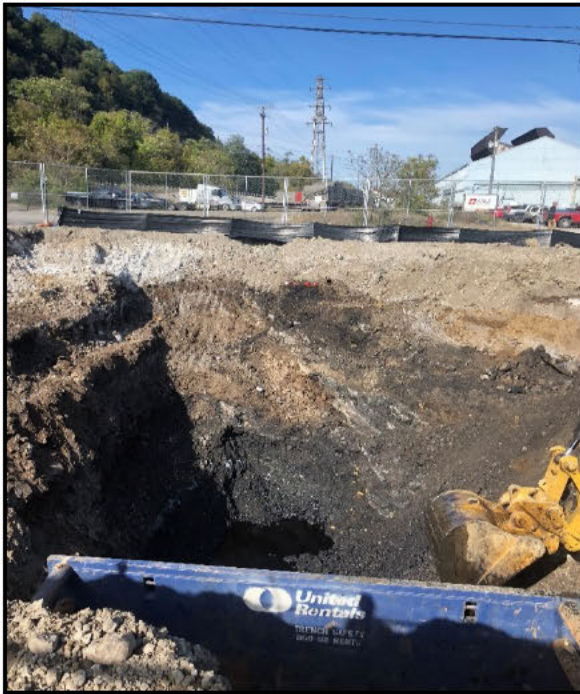
Photolog 55: North side of excavation while making bench for excavator. Pocket of oil and impacted groundwater near bottom of picture. 10/22/18 (START photo IMG_1600.jpg)

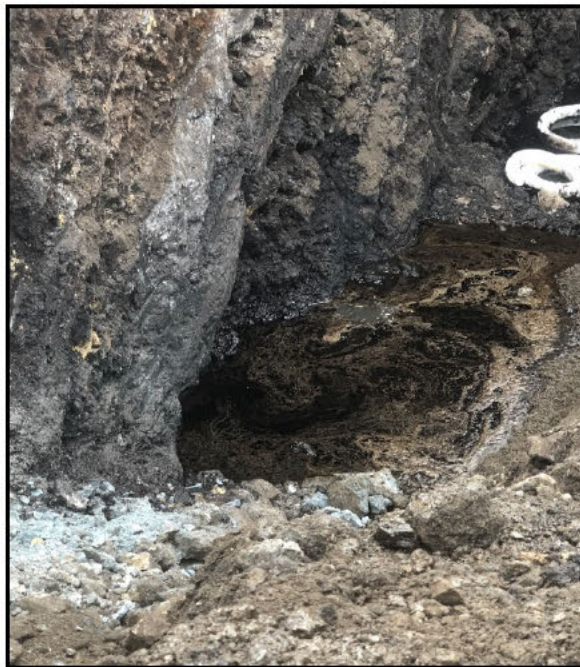
Photolog 57: Excavation of the south side of the storm water piping. Water impacted from oil seeps. 10/25/18. (START photo IMG_1637.jpg)

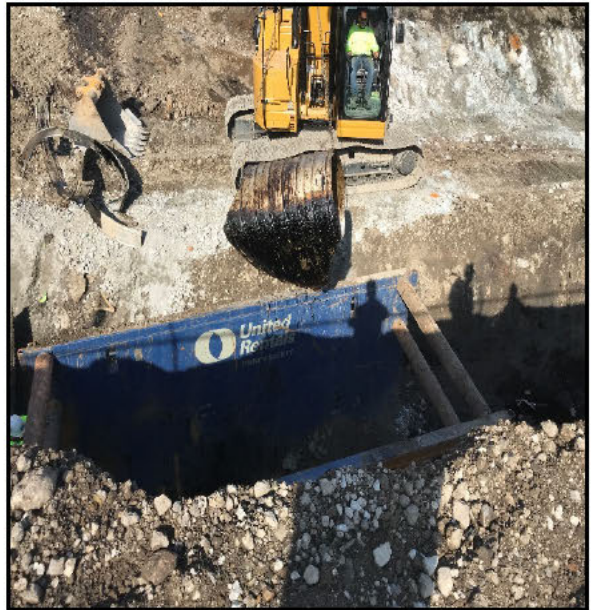
Photolog 62: Removing section of storm water piping that included the infiltration point shown on camera. This section was also damaged during excavation operations. 10/30/18. (START photo IMG_8764.jpg)

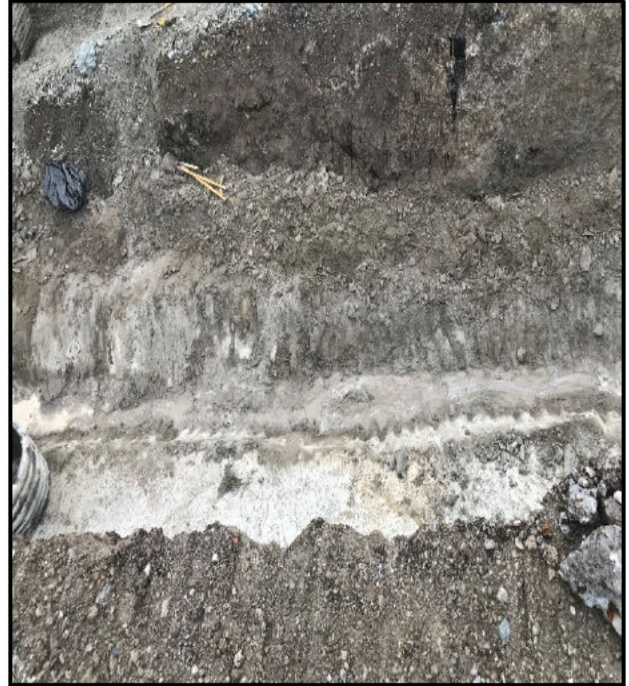
Photolog 72: Fill material sealed off the bottom of the channel with cement. 11/1/18 - (START photo IMG_8986.jpg)

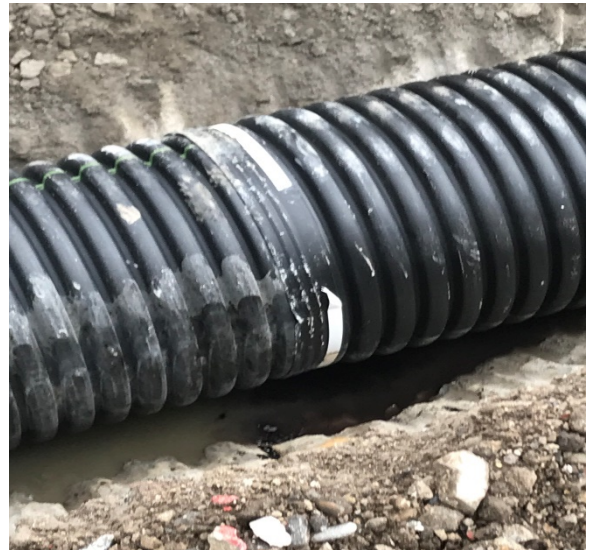
Photolog 76: Close-up of bell and spigot joint on the HDPE piping. 11/2/18 (START photo IMG_9018.jpg)

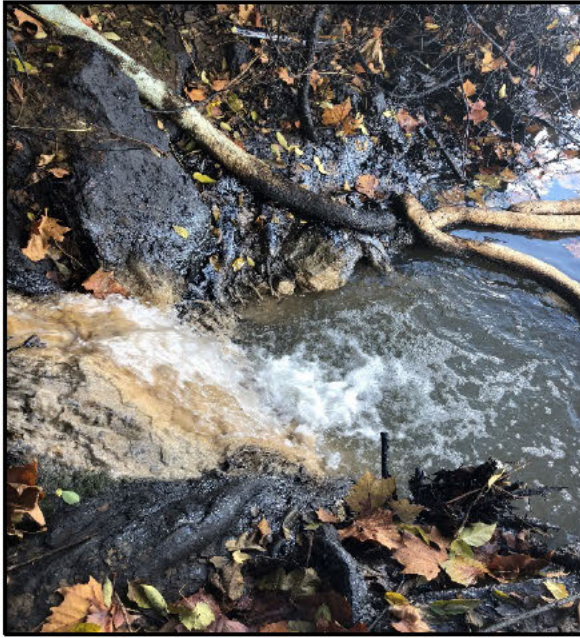
Photolog 79: Conditions at outfall after new HDPE piping and placement of flowable cement. No visible oil being discharged. 11/6/18 (START photo IMG_1906.jpg)

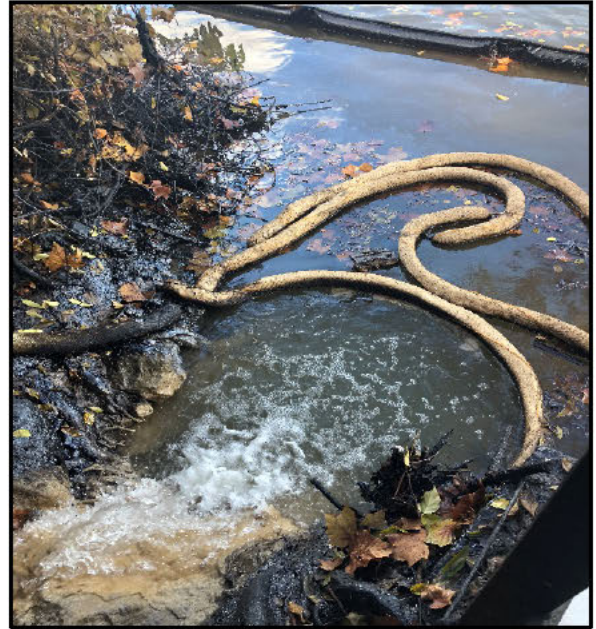
Photolog 80: Conditions at outfall after new HDPE piping and placement of flowable cement. No visible oil being discharged. 11/6/18 (START photo IMG_1908.jpg)

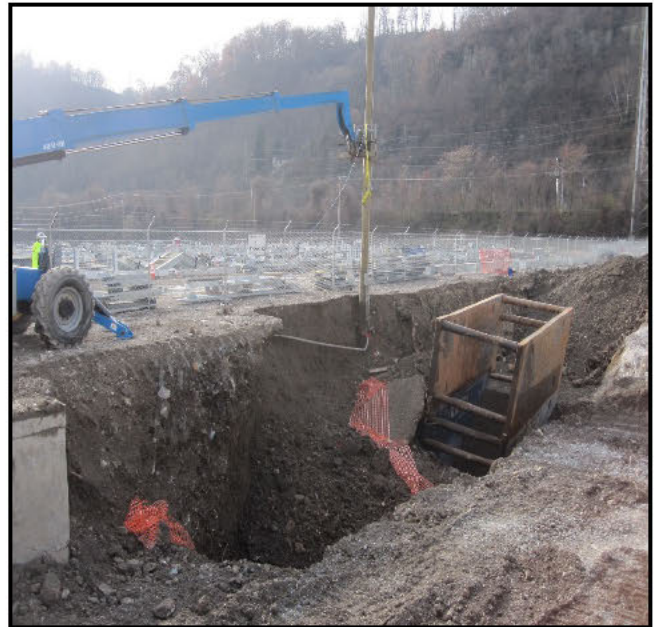
Photolog 94: Working close to a utility pole. Pole secured by a lift in case we lost the pole. Side wall slipped and lost electricity although pole remained upright. 12/13/18 (START photo IMG_1235.jpg)

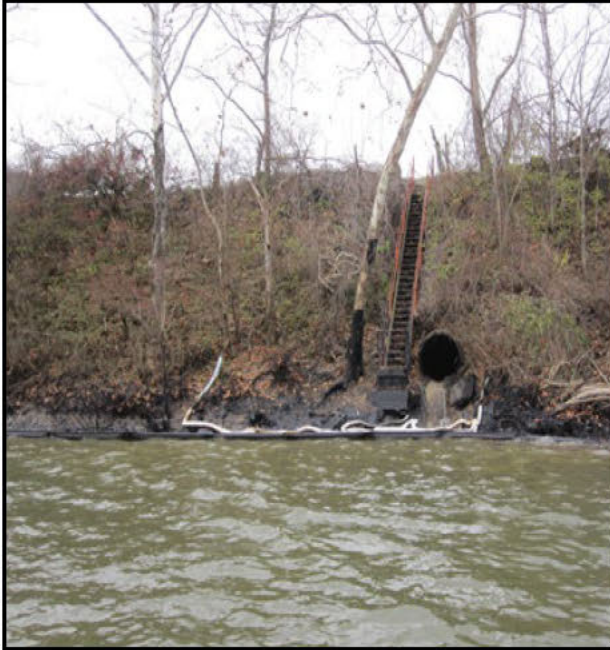
Photolog 95: - Photos taken from river to document conditions at outfall and riverbank. Facing west. 12/6/18 (START photo IMG_1201.jpg)

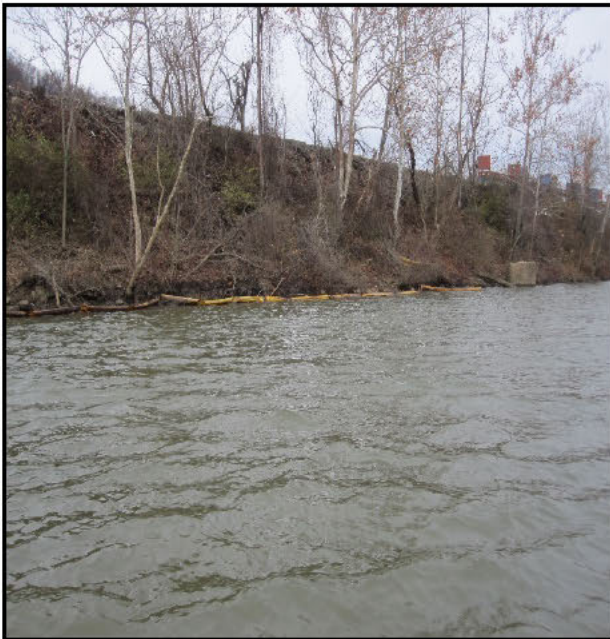
Photolog 97: Photos taken from river to document riverbank conditions on the northern side of the outfall. Facing west. 12/6/18. (START photo IMG_1196.jpg)

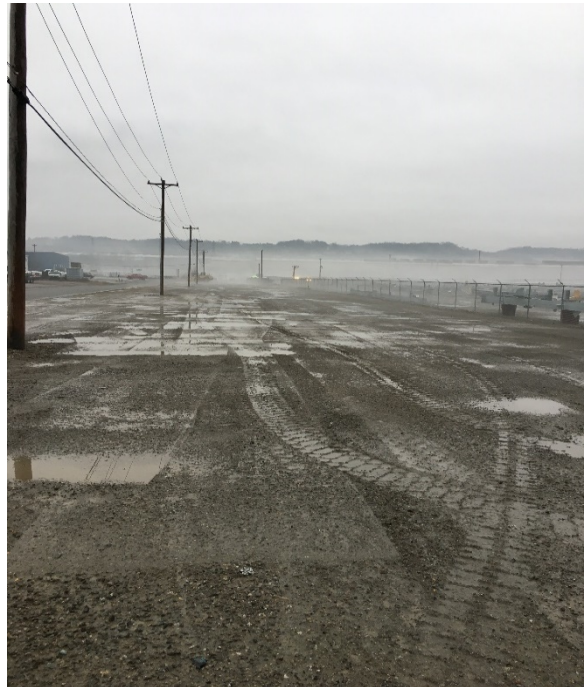
Photolog 102: Final conditions at the work area bordering Woodlawn Road and Steel Street. Facing east. 2/5/19. (EPA photo IMG_0436.jpg)

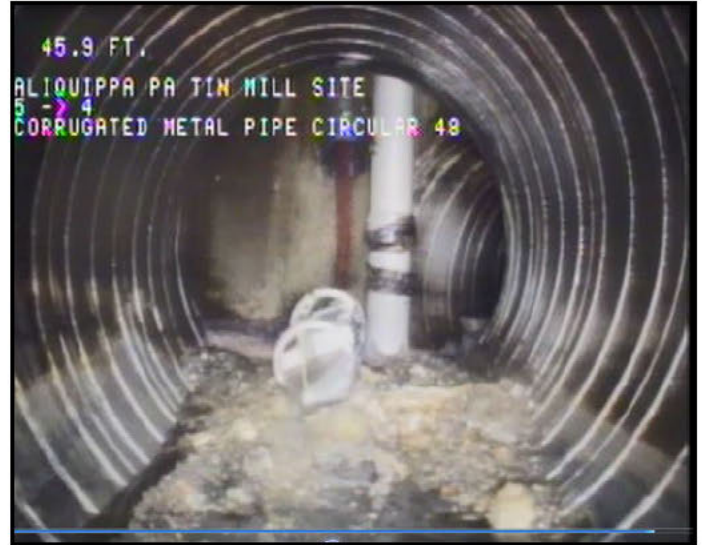
Photolog 104: Photo of piping conditions after cleaning at Inlet #4. Material is cement and cannot be removed. 12/3/18. Photo extracted from camera survey video.

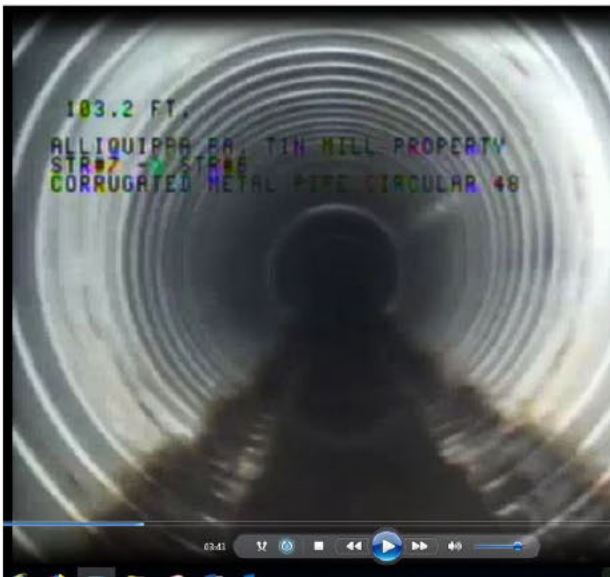
Photolog 105: Photo of storm water piping conditions before cleaning. Photo extracted from camera survey video. 10/10/18

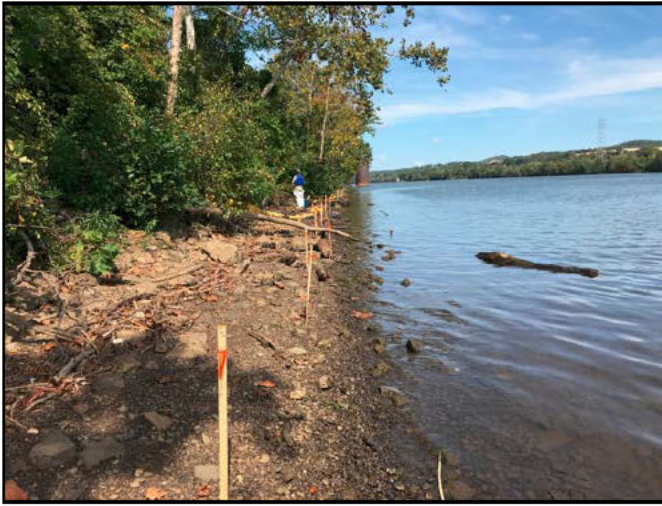
Photolog 107: Facing N. Wooden stakes placed every 10 feet 11th of the outfall. 9/17/19. (START photo IMG_0936)

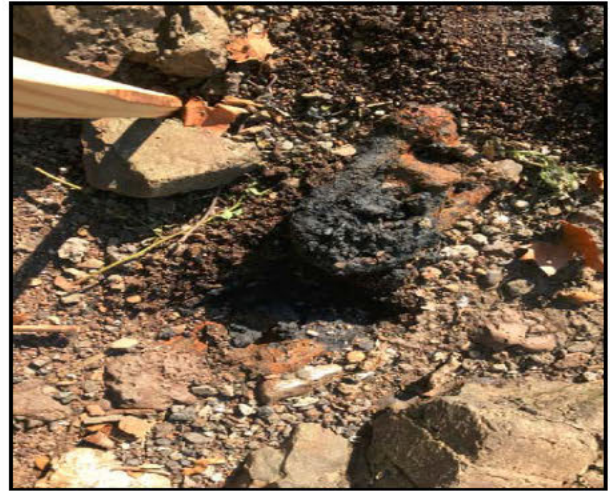
Photolog 108: Facing Down. Rock and material showing dark oil stains. 09/19/19. (START photo IMG_0336)

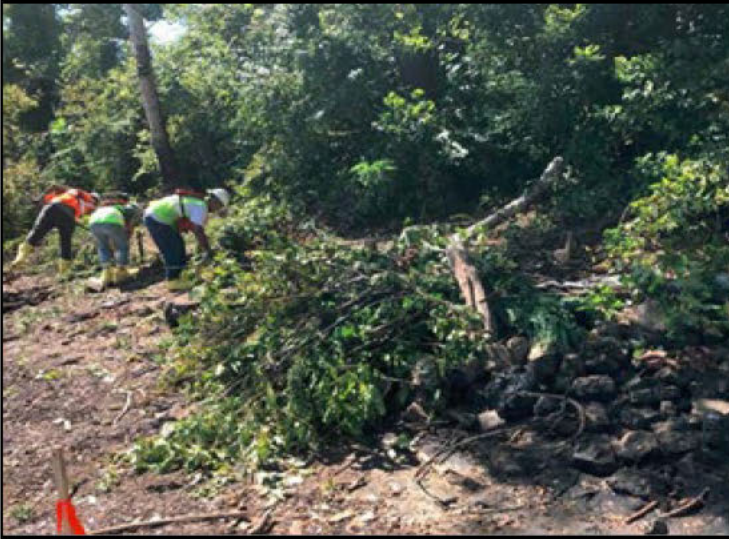
Photolog 111: Facing SW. Vegetation being removed south of outfall. 09/19/19. (START photo IMG_0945)

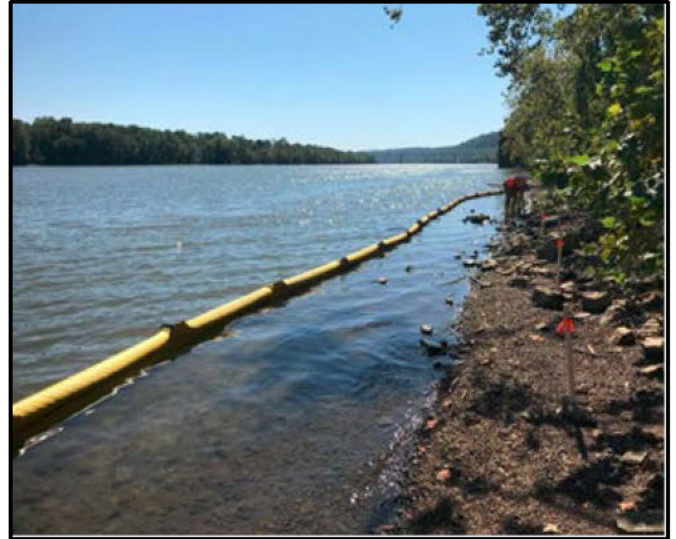
Photolog 112: Facing South. Harbor boom placed in river. 09/19/19. (START photo IMG_0947)

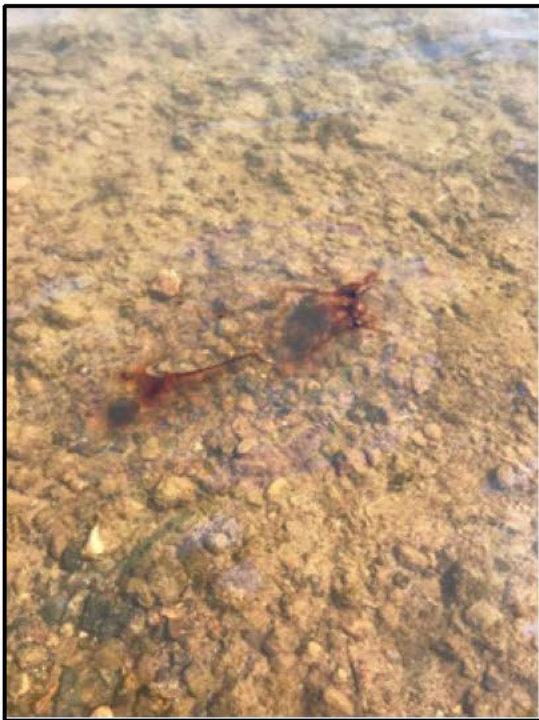
Photolog 113: Facing Down. Oil and rainbow sheen released when removing large rocks in front of outfall. 09/19/19. (START photo IMG_0949)

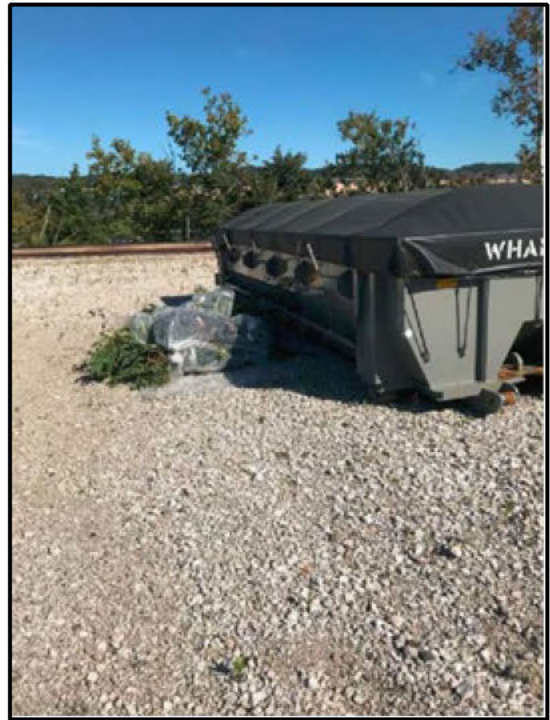
Photolog 114: Facing East. Bags of vegetation removed from along river bank, disposed of in roll-off container (pictured). 09/19/19. (START photo IMG_0342)

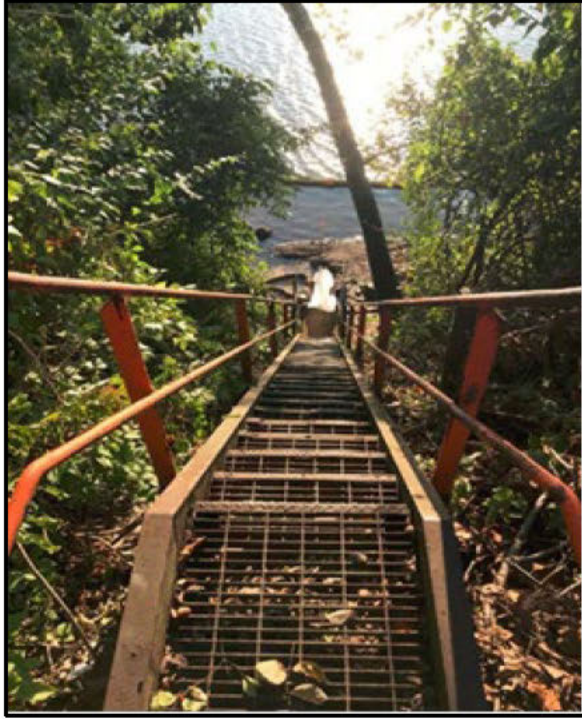
Photolog 115: Facing Down. Stairs leading down to riverbank and outfall. 09/20/19. (START photo IMG_0953)

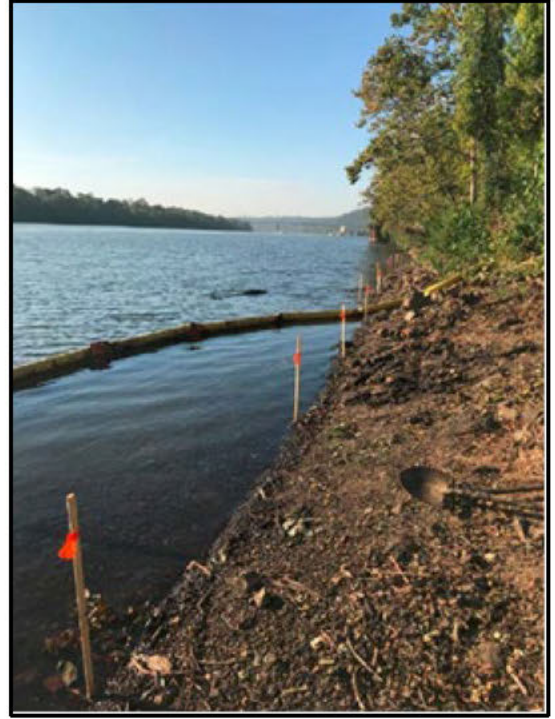
Photolog 116: Facing S. Wooden stakes south of outfall. Water level rose approximately 3-4 inches. 09/20/19. (START photo IMG_0955)

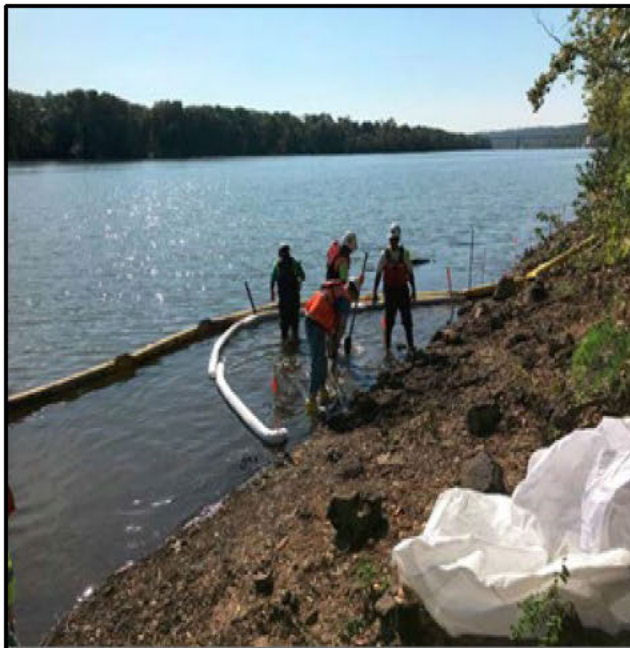
Photolog 117: Facing SE. ERRS agitating sediment at 240'-260' interval. 09/20/19. (START photo IMG_0958)

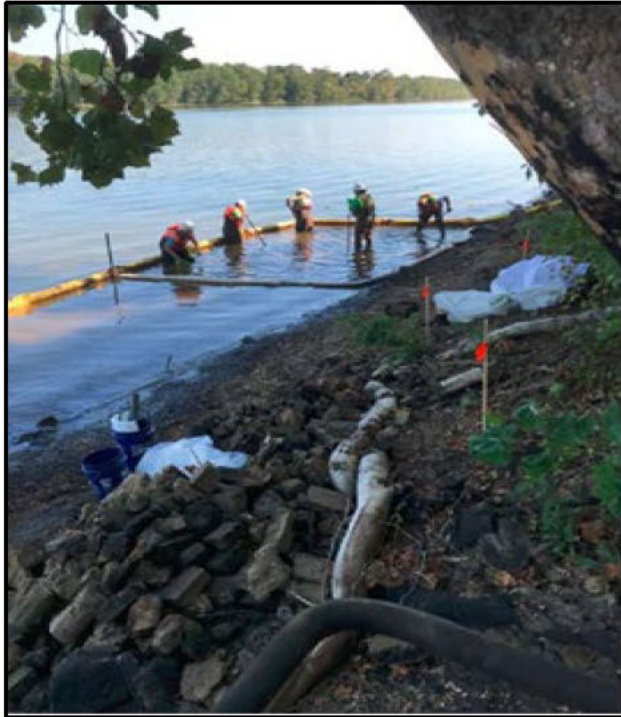
Photolog 119: Facing S/SE. ERRS agitating sediment within 240' - 260' interval. 09/20/19. (START photo IMG_0350)

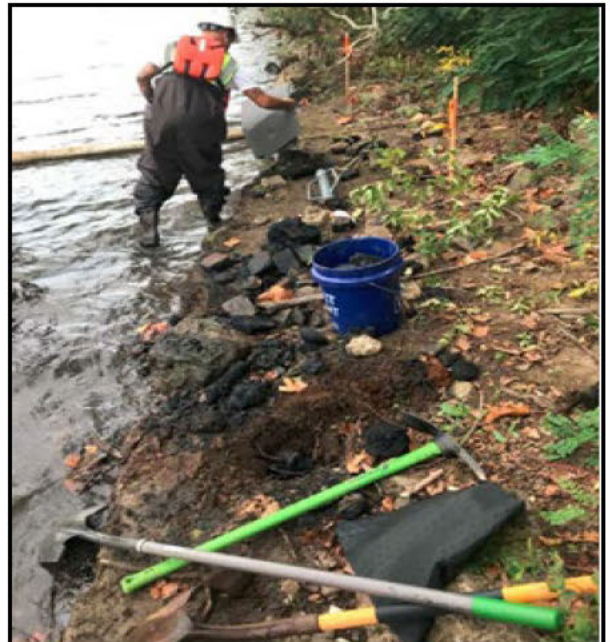
Photolog 122: Facing S. Oil stained rocks and bricks placed on bank from 340'-360' interval. 9/23/19. (START photo IMG_0971)

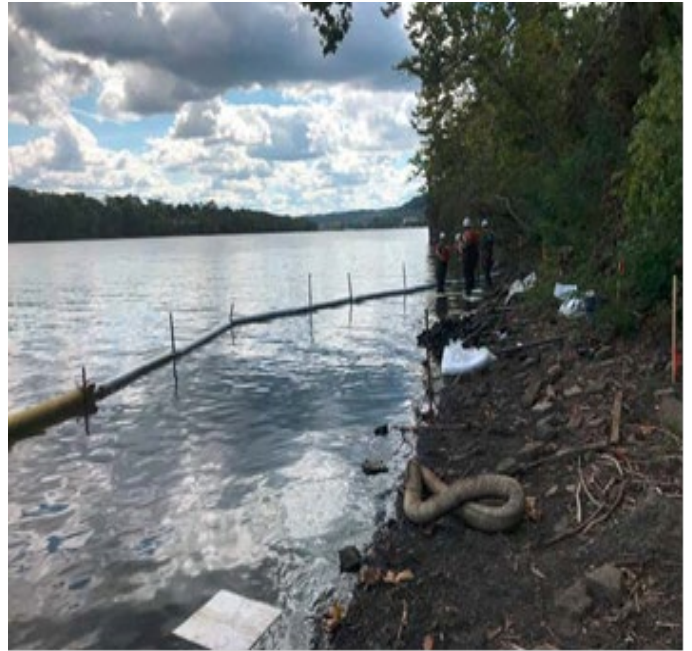
Photolog 124: Facing S. ERRS connected absorbent boom to harbor boom to have boom spanning from 0'-360'. 9/24/19. (START photo IMG_0993).

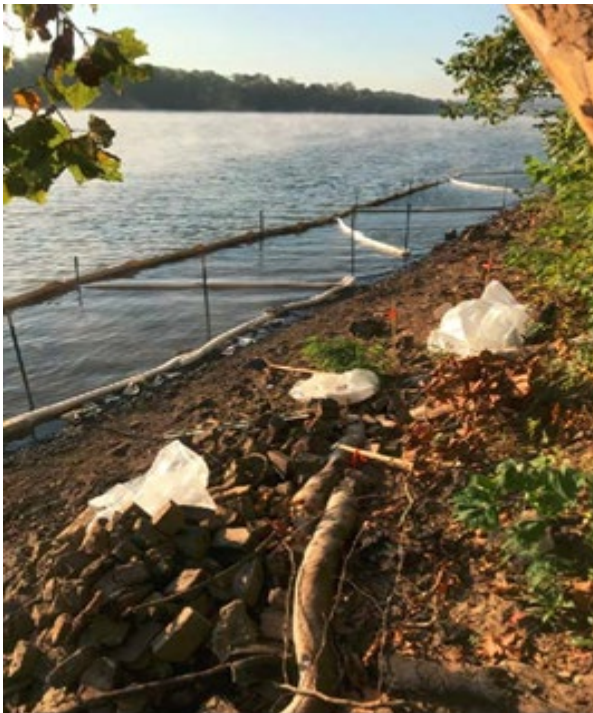
Photolog 125: Facing S/SE. Triangular arrangement of absorbent boom between 260' - 360' interval. 09/25/19. (START photo IMG_0352).
